## Inspection Report Minerals Regulatory Program

Mine Name: Lisbon

Operator Name: Rio Algom

Inspector(s): Paul Baker Other Participants: None Mine Status: Reclaimed **Permit number:** M0370001 **Inspection Date:** April 29, 2008

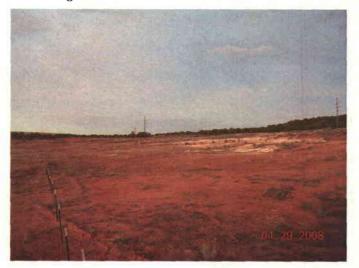
Photo 1. Note that much of the area is fairly flat and has limited vegetation.

The Division and the operator need to continue monitoring for revegetation success. If vegetation from desirable species does not improve by this fall, the operator should consider re-scarifying the surface and re-seeding.
